## **Malfunction Coatron A4/A6/A6Plus/5000: Poor precision of results**

### **Error description:**

Instrument gives prolonged or imprecise clotting time or +++ or replicates are 20% and more in difference to first run.

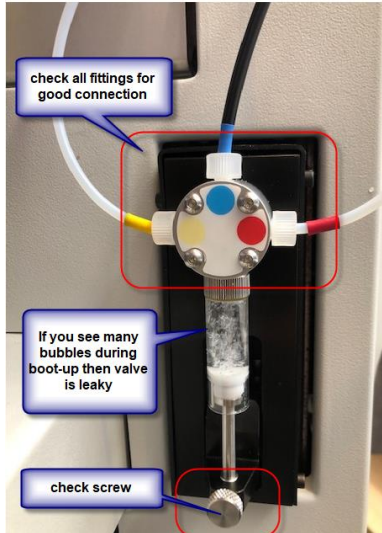
| <p>Step-4 : Check for leaky valve</p> | <p>During boot-up the instruments performs a complete wash cycle. Watch carefully</p> <ul style="list-style-type: none"> <li>• The valve or tubing is leaky in case of airbubbles like on the picture</li> <li>• Check that syringe-screw is connected</li> <li>• Check that tube fittings are connected</li> <li>• Check that needle is washed inside and outside with rinse solution.</li> </ul> |

| Instrument problems | check | | trouble shoot |
|---|---|---|---|
| | Valve is leaky | Check for air bubbles in the syringe during washing ( see next page Step-4) | Replacement |

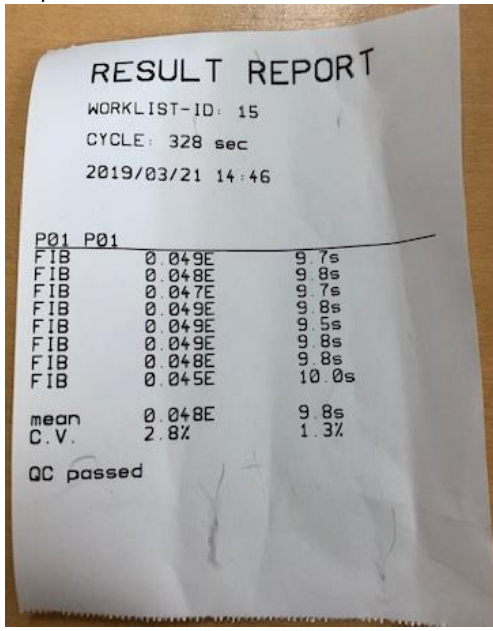
| <p>Step-5: Perform FIB QC test</p> | <ul style="list-style-type: none"> <li>• Place on-board FIB, IBS reagent + Normal control to P01</li> <li>• Goto meu ANALYSIS/NEW LIST and set mode="QC"</li> <li>• Install paper into printer and start QC test</li> <li>• C.V. &lt; 7.5% and E &gt; 0.030E → Everything is fine</li> </ul> <p>QC-Results:</p> <ul style="list-style-type: none"> <li>- Failed if C.V. &gt; 7.5%<br/>Higher results indicate false alignment of cuvette, imprecise volumes (needle, syringe, pump), carryover (needle, wash position)</li> <li>- Failed if Mean of "E" &lt; 0.030E</li> </ul> <p>Results below indicate false alignment of cuvette or problem with normal control or FIB reagent</p> |

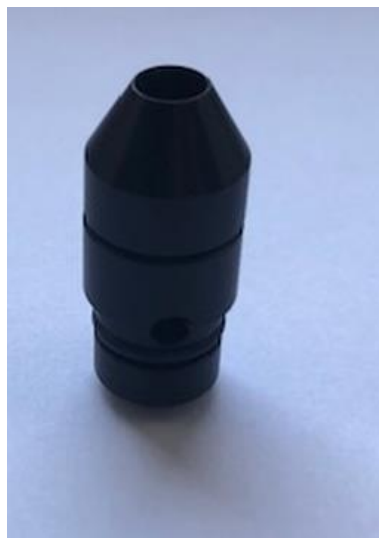
Old clean position: REF= 21 034 00 ©

Compatibility: With all firmware version  
Service plan: Replacement every 50.000 tests

**Step-6: Upgrade clean position 21 034 00**

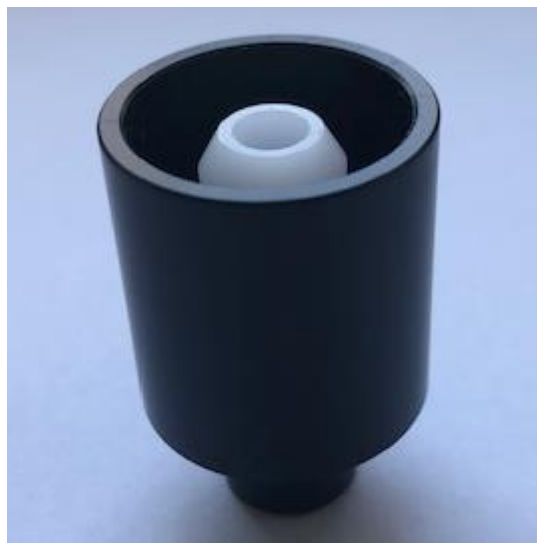
New clean position: REF= 21 034 50 (a)

Compatibility: Only with firmware versions released after 2019  
Service plan: No regular replacement required

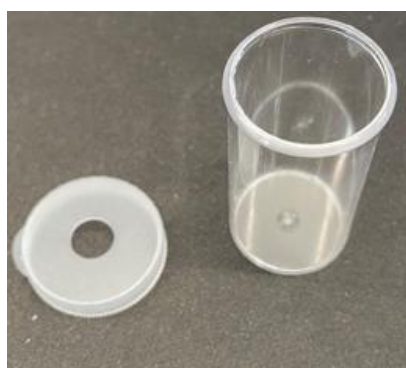
TECO caps with 8mm hole  
REF = 80 525 05

TECO 10mL container tend to high evaporation, which can lead to carryover of CLEAN solution or instability of reagents. The special caps reduce evaporation significantly

Apply TECO caps with 8mm hole, if placing reagents or CLEAN solution onboard within 10mL container.

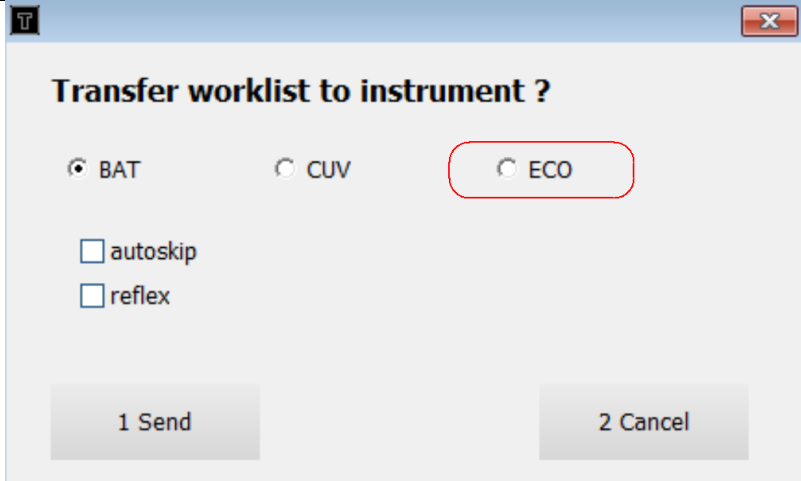
TECAM PRO software

In ECO mode the systems performs single dispensing, which is positive to precision and consumption (see below).

If service and part replacement does not improve the precision, then using the “ECO” mode might help. Especially with Coatron A4 it might improve significantly.
