## Malfunction: False levelsensing on Coatron A4

### Error Description:

Sometimes the needle does stop in air instead of liquid. This is caused by poor electrical contact from Alidum sensor over golden plug to insulation block and/or by defect insulation block, Alidum sensor or ADRI board. It is solved normally by two fixes:

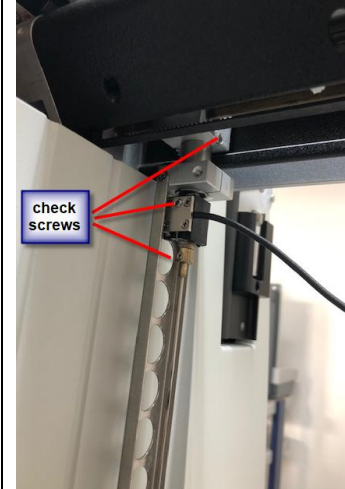
| 1. insulation block,<br>poor electrical contact | Check <ul style="list-style-type: none"><li>- connections ( Pic-1)</li><li>- overturn screw (Pic-2)</li><li>- COAX cable broken</li><li>- Golden plug not fixed (Pic-9=</li></ul> |

| Pic1 Check tight connections | Pic2 Check, if z-screw was overturned | Pic3 Spare part: Insulationblock Rev "D", COAX cable on right side |

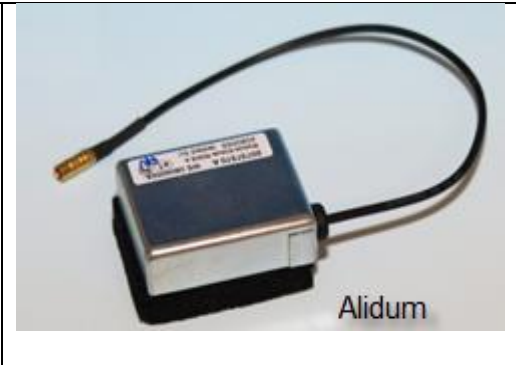
| 2. insulation block,<br>coax cable is broken | Run check robotics (Pic-6) <ul style="list-style-type: none"><li>- Remove all vials and add one cuvette</li><li>- Start check</li><li>- During level sensing touch cable and z-rack. If needle stops and printer give "false level" then the insulation block is defect.</li></ul> |

| Pic4 spare part ADRI board | Pic5 Spare part: Alidum | Pic6 Check function of level sensor |

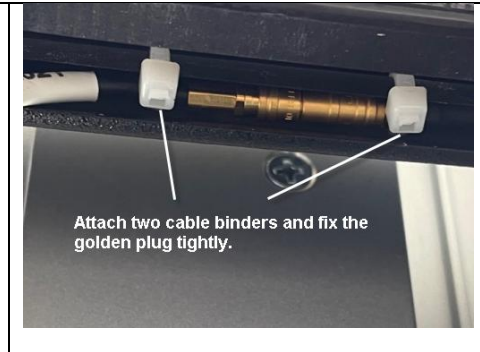
| 3. Golden Plug is not fixed | Use two cable binders to fix the golden plug (Pic-9) <ul style="list-style-type: none"><li>- Attach near the ends of plug</li><li>- Attach tightly</li></ul> |

| Pic7 Check Home position and Flag | Pic8 Check Sensor | Pic9 Fix golden plug of coax cable with two cable binders. |

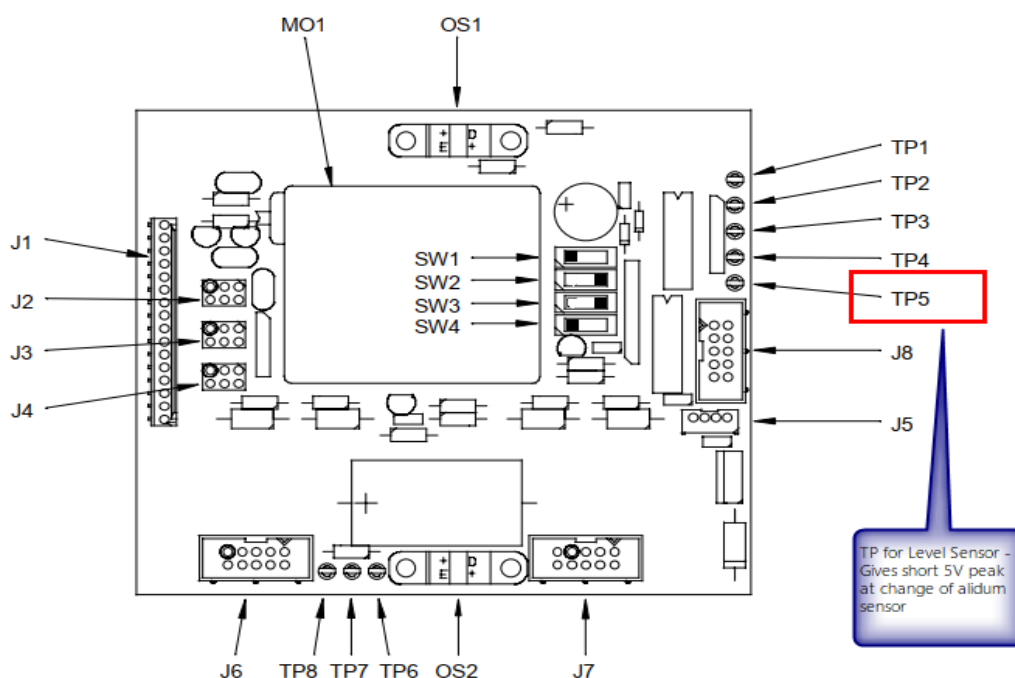
Pic-11: ADRI Board (SW3 is here enabled)

| 7. Alidum sensor is defect | check TP5 (pic-11) <ul style="list-style-type: none"><li>- Follow „How to check the Alidum sensor</li></ul> |

The TP5 should be 0V in idle mode. After change of capacity (e.g. by touch or release the needle) it must give a short pulse signal ( TTL, 5V).

- If no signal change can be measured , then the COAX cable has no connection
- If signal changes are caused by movements of cabling, then the COAX cable is broken or corroded
