## Malfunction: False levelsensing on Coatron A4

### Error Description:

Sometimes the needle does stop in air instead of liquid. This is caused by poor electrical contact from Alidum sensor over golden plug to insulation block and/or by defect insulation block, Alidum sensor or ADRI board. It is solved normally by two fixes:

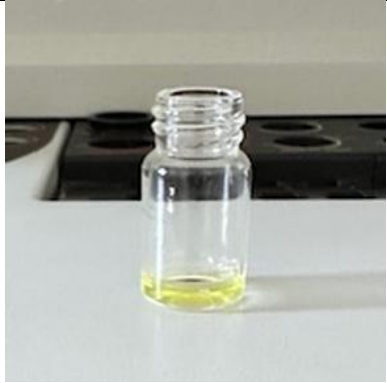
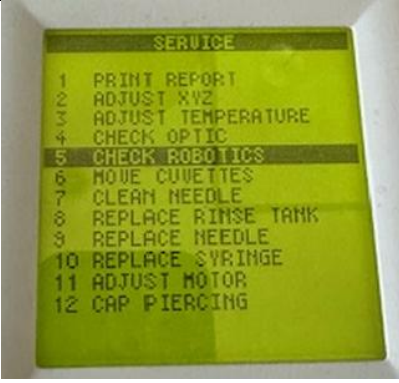
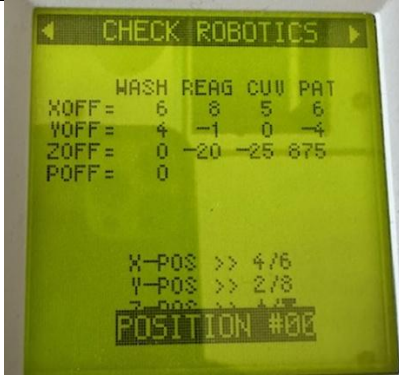
## 2-How to check liquid level detection of PT vial:

| <p>1)Pipet 300µl drinking water and place vial to P25. (the water here is colored just for better presentation)</p> | <p>2)Goto SERVICE and press "5" to start.</p> | <p>3)When needle moves to P1, P2; Press "ESC" to break auto-run.</p> |

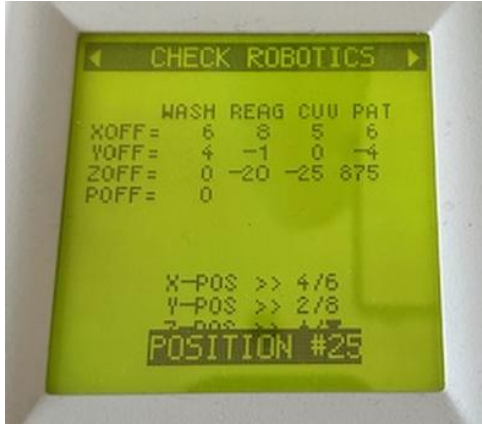
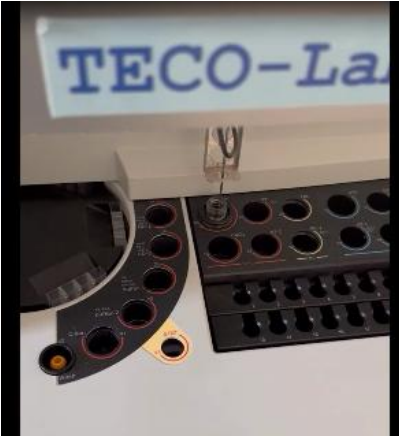
| <p>4)Drive needle to P25.</p> <p>Press left/right to switch <math>\pm 1</math><br/>Press left/right + "0" <math>\pm 10</math></p> <p>ZOFF (wash) must be [-10 to +10]<br/>ZOFF (reag) must be [-20 to +10]<br/>ZOFF (cuv) must be [-25 to +10]<br/>ZPAT (cuv) must be [825 - 875]<br/>POFF (Piercing) must be "0"</p> <p>➔ If not, exit screen ( ESC) and run menu 2 "ADJUST XYZ"</p> | <p>5)Press Down to activate level searching.</p> <p>During move touch z-rack and or z-cable or snip finger slightly to z-rack.</p> <p>Needle should always with vialtop at level. If it does not, adjust XYZ (deeper Z-offset).</p> | <p>6)Remove needle (don't open fitting on valve !) and</p> <p>Press Down to activate level searching. Needle should stop at level. If it does not, adjust XYZ (deeper Z-offset).</p> |

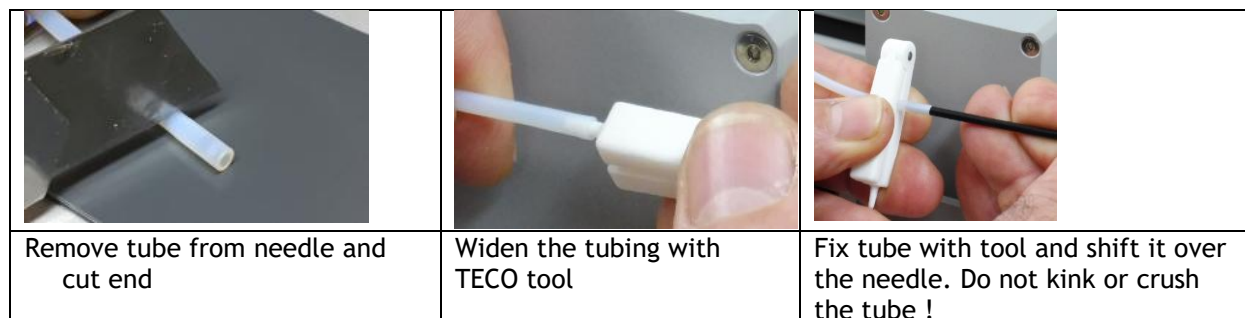
### 3-How to fix leaky tube

| 4. Water is inside of Z-Rack | Happens, if tubing is leaky <ul style="list-style-type: none"><li>- Follow „How to fix leaky tube"</li><li>- Remove needle can check tubing</li><li>- Remove insulation block and blow out all liquid</li><li>- Remove z-rack and blow out all liquid</li></ul> |

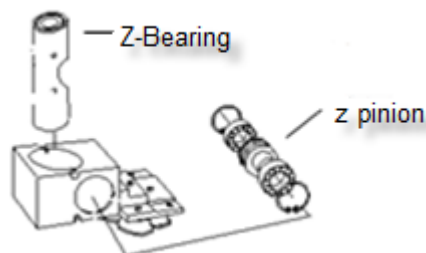
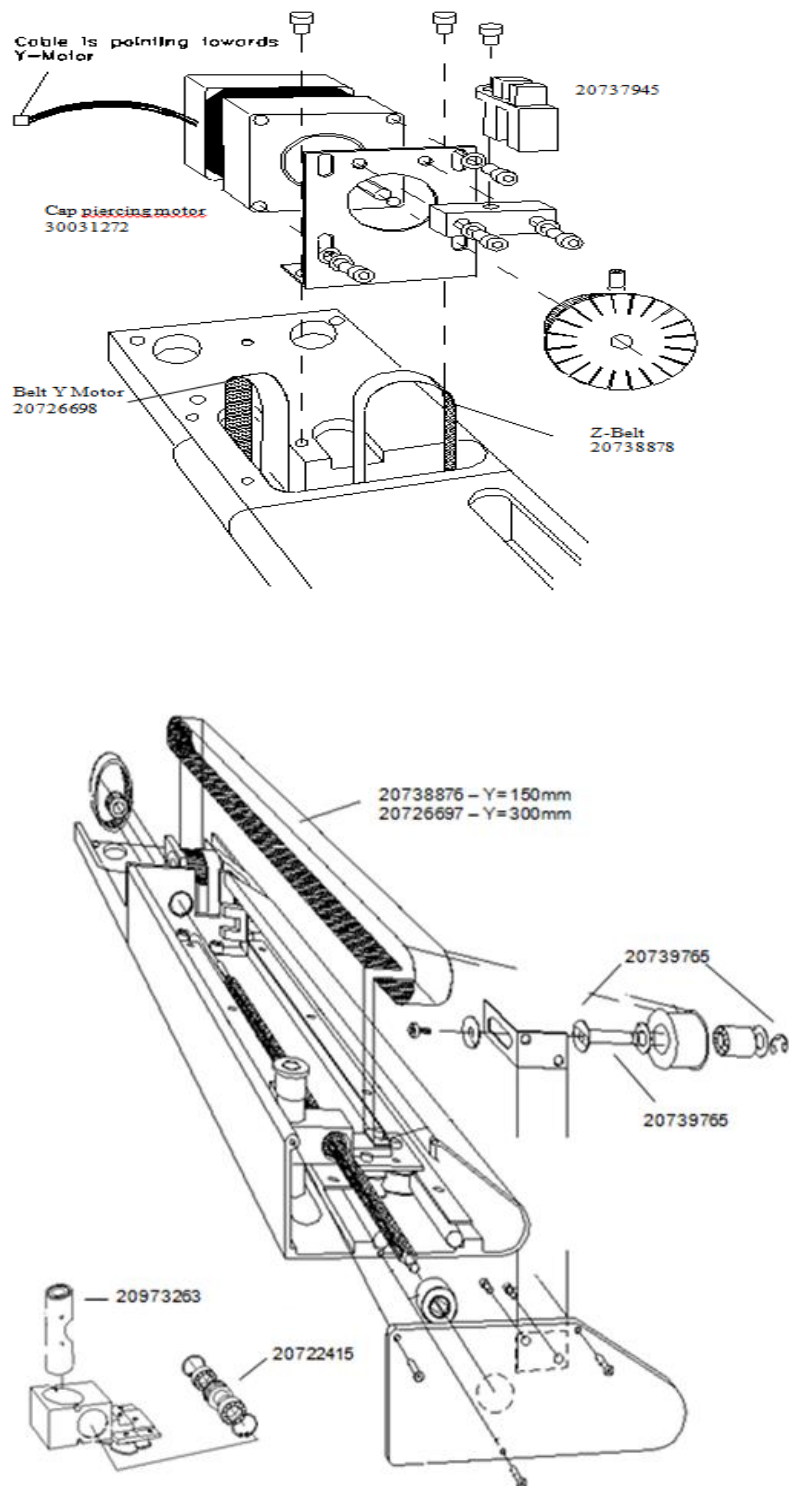
Pic-11: Spare parts of XYZ robotic

| 9. Z-bearing worn out | replace z-bearing+z-pinion (see PIC-11) <ul style="list-style-type: none"><li>- Follow „How to overhaul the XYZ system</li></ul> |

- Replace all belts (x,y,z)
- Replace Z-Pinion
- Replace Flatcable
- Replace Y-Pulley ( Umlenkrolle)
- Clean all wheels, rollers and guide rails with alcoholic solution and lubricate with silica oil. Apply only a very thin film.
- Check Z-Bearing and replace if required
